Tyne Pedestrian & Cyclist Tunnels

Refurbishment Progress November 2013

TYNE AND WEAR
INTEGRATED TRANSPORT AUTHORITY

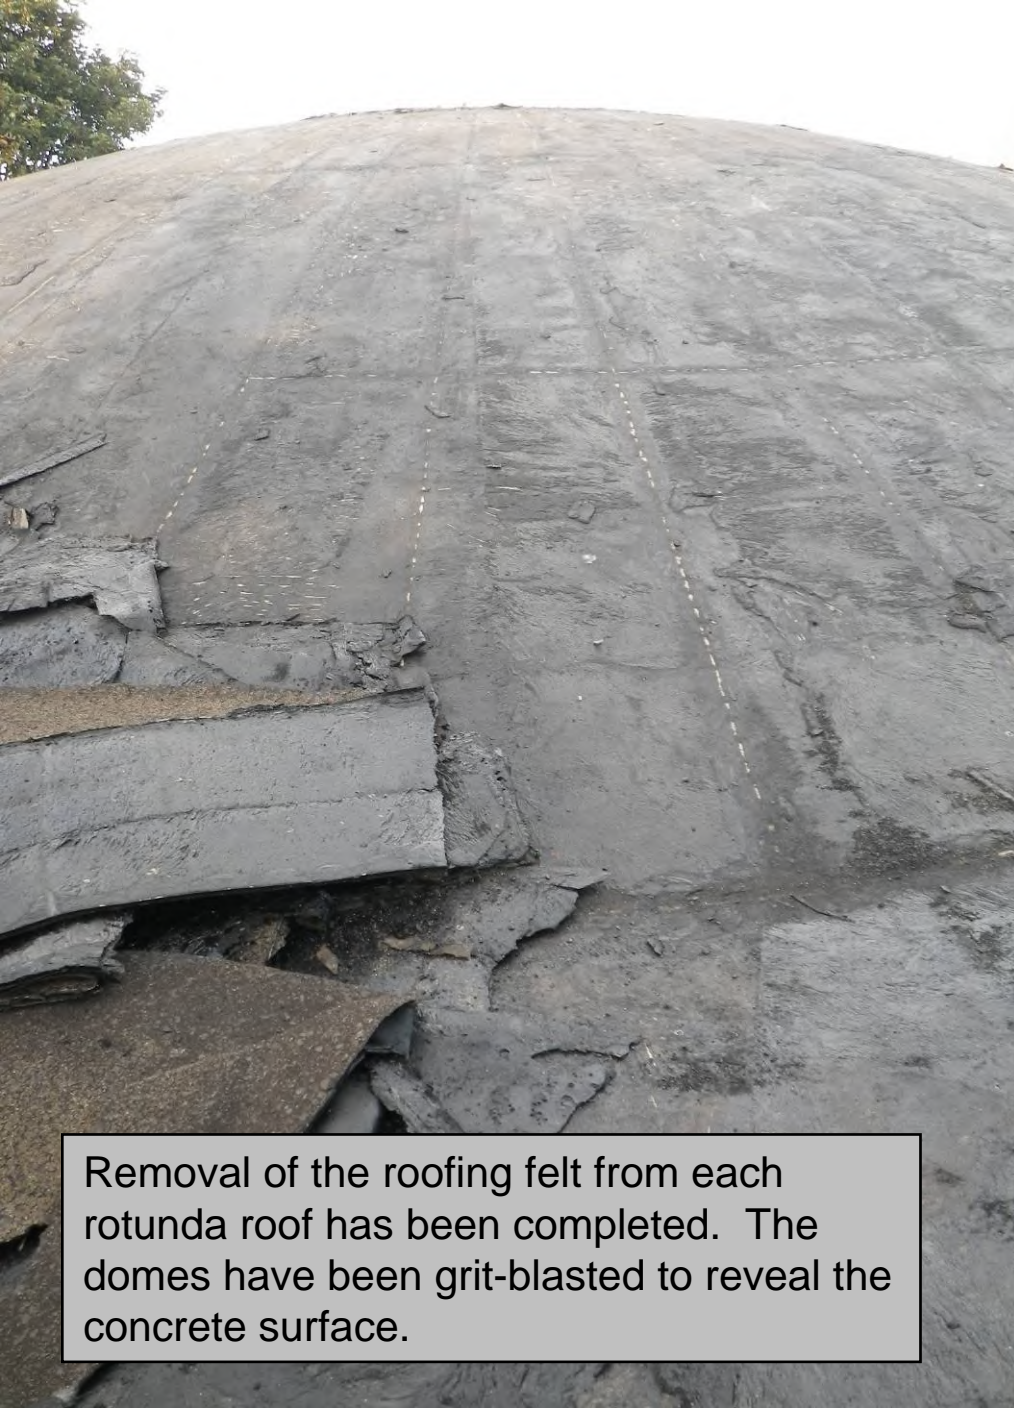
Removal of the roofing felt from each rotunda roof has been completed. The domes have been grit-blasted to reveal the concrete surface.

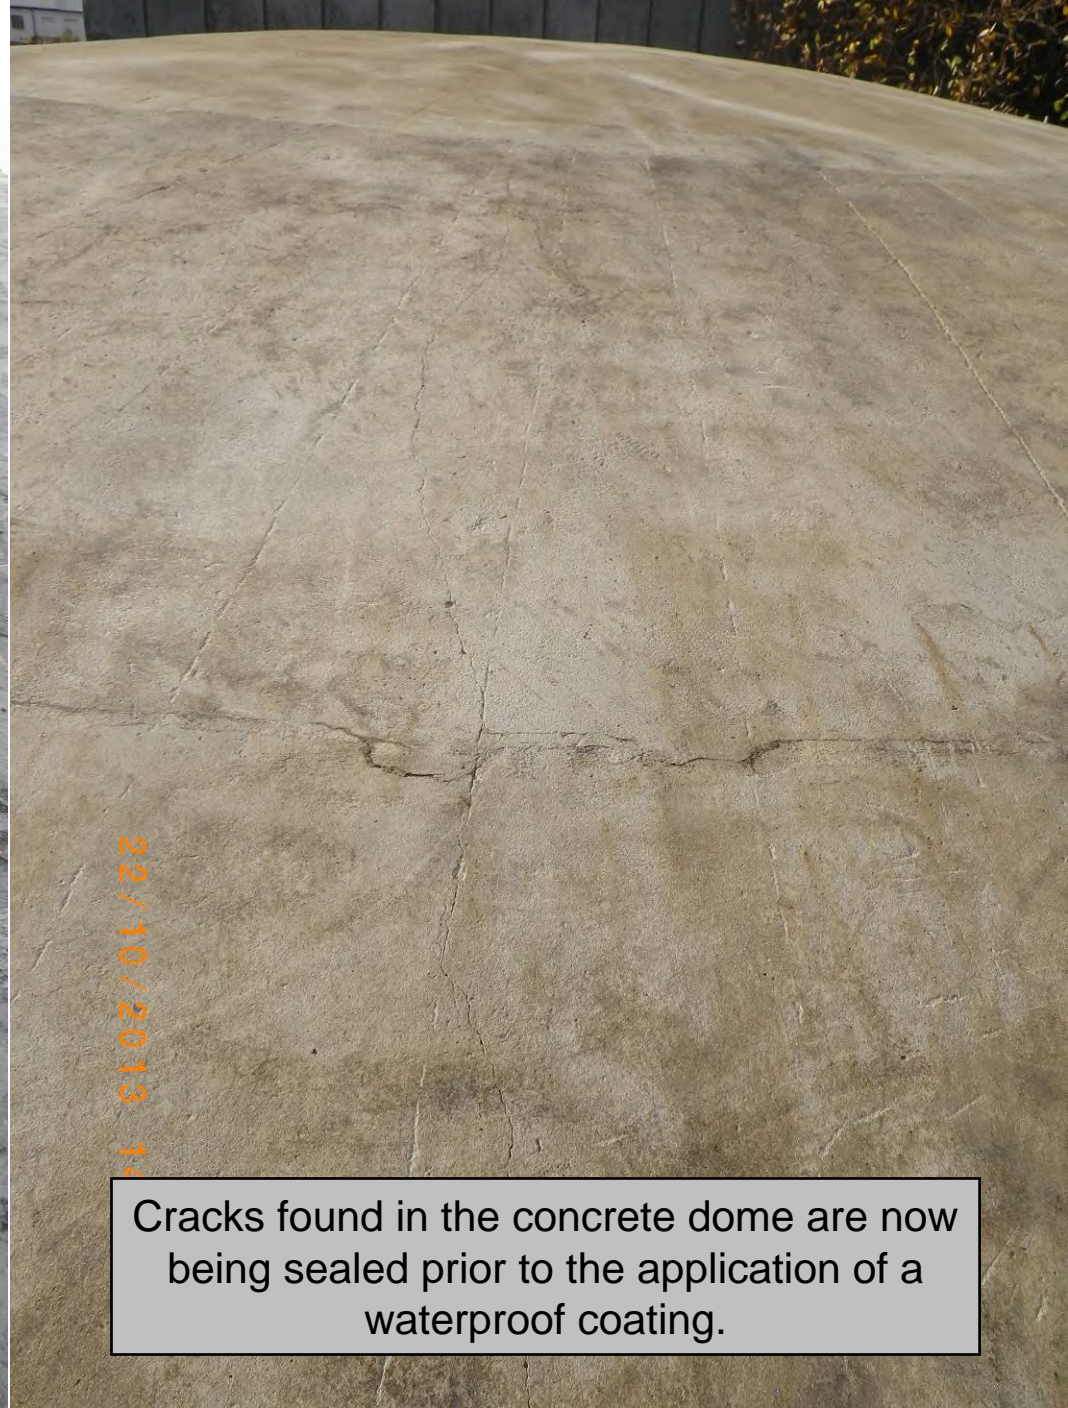
22/10/2013 11:11

Cracks found in the concrete dome are now being sealed prior to the application of a waterproof coating.

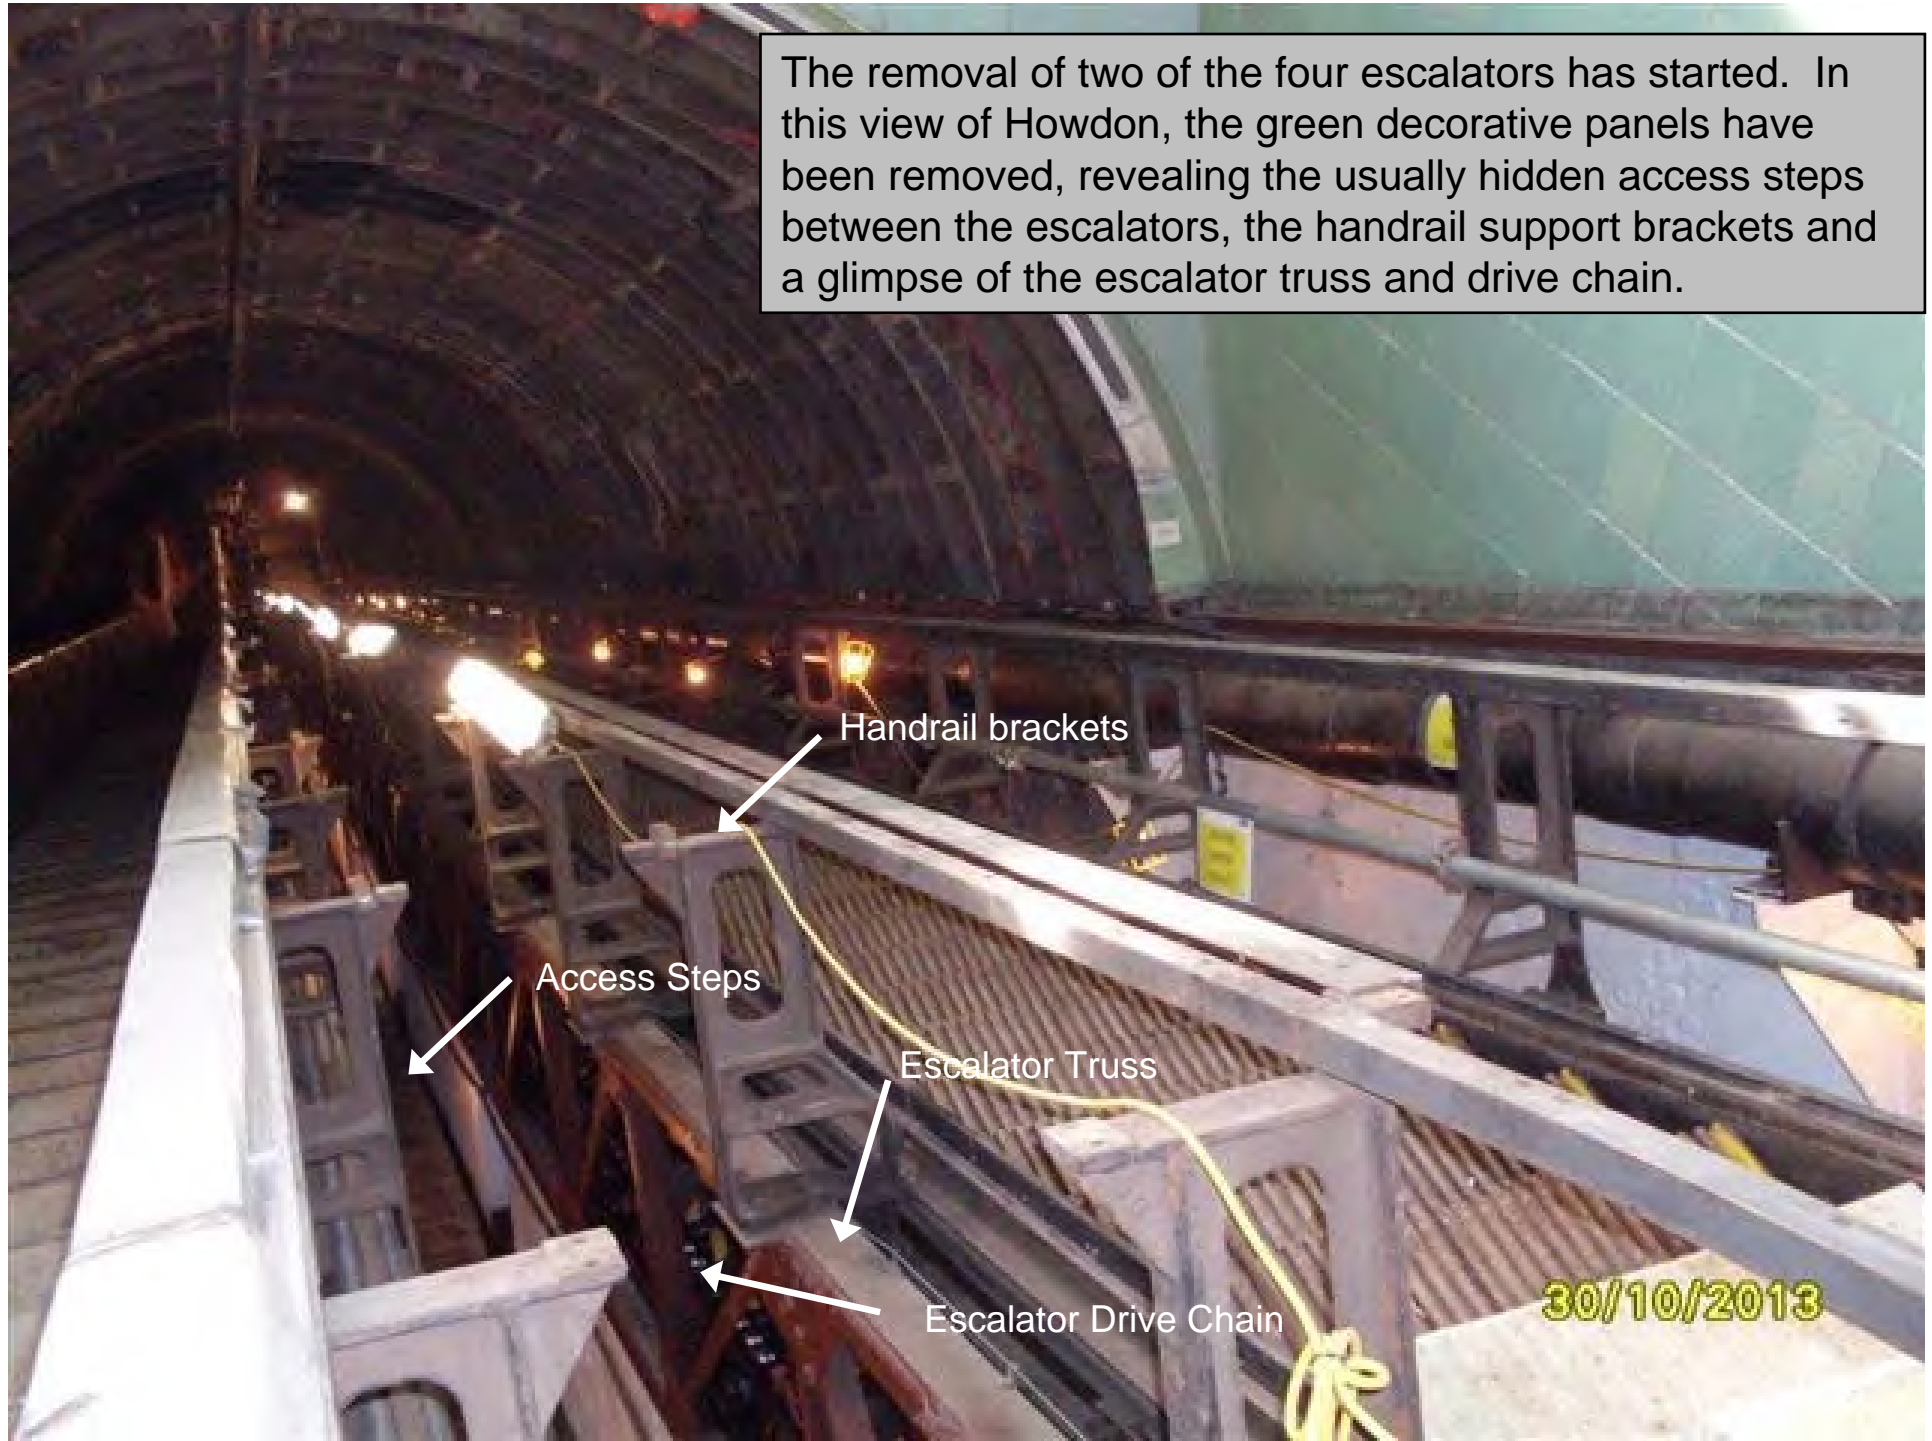
30/10/2013

The removal of two of the four escalators has started. In this view of Howdon, the green decorative panels have been removed, revealing the usually hidden access steps between the escalators, the handrail support brackets and a glimpse of the escalator truss and drive chain.

Handrail brackets

Access Steps

Escalator Truss

Escalator Drive Chain

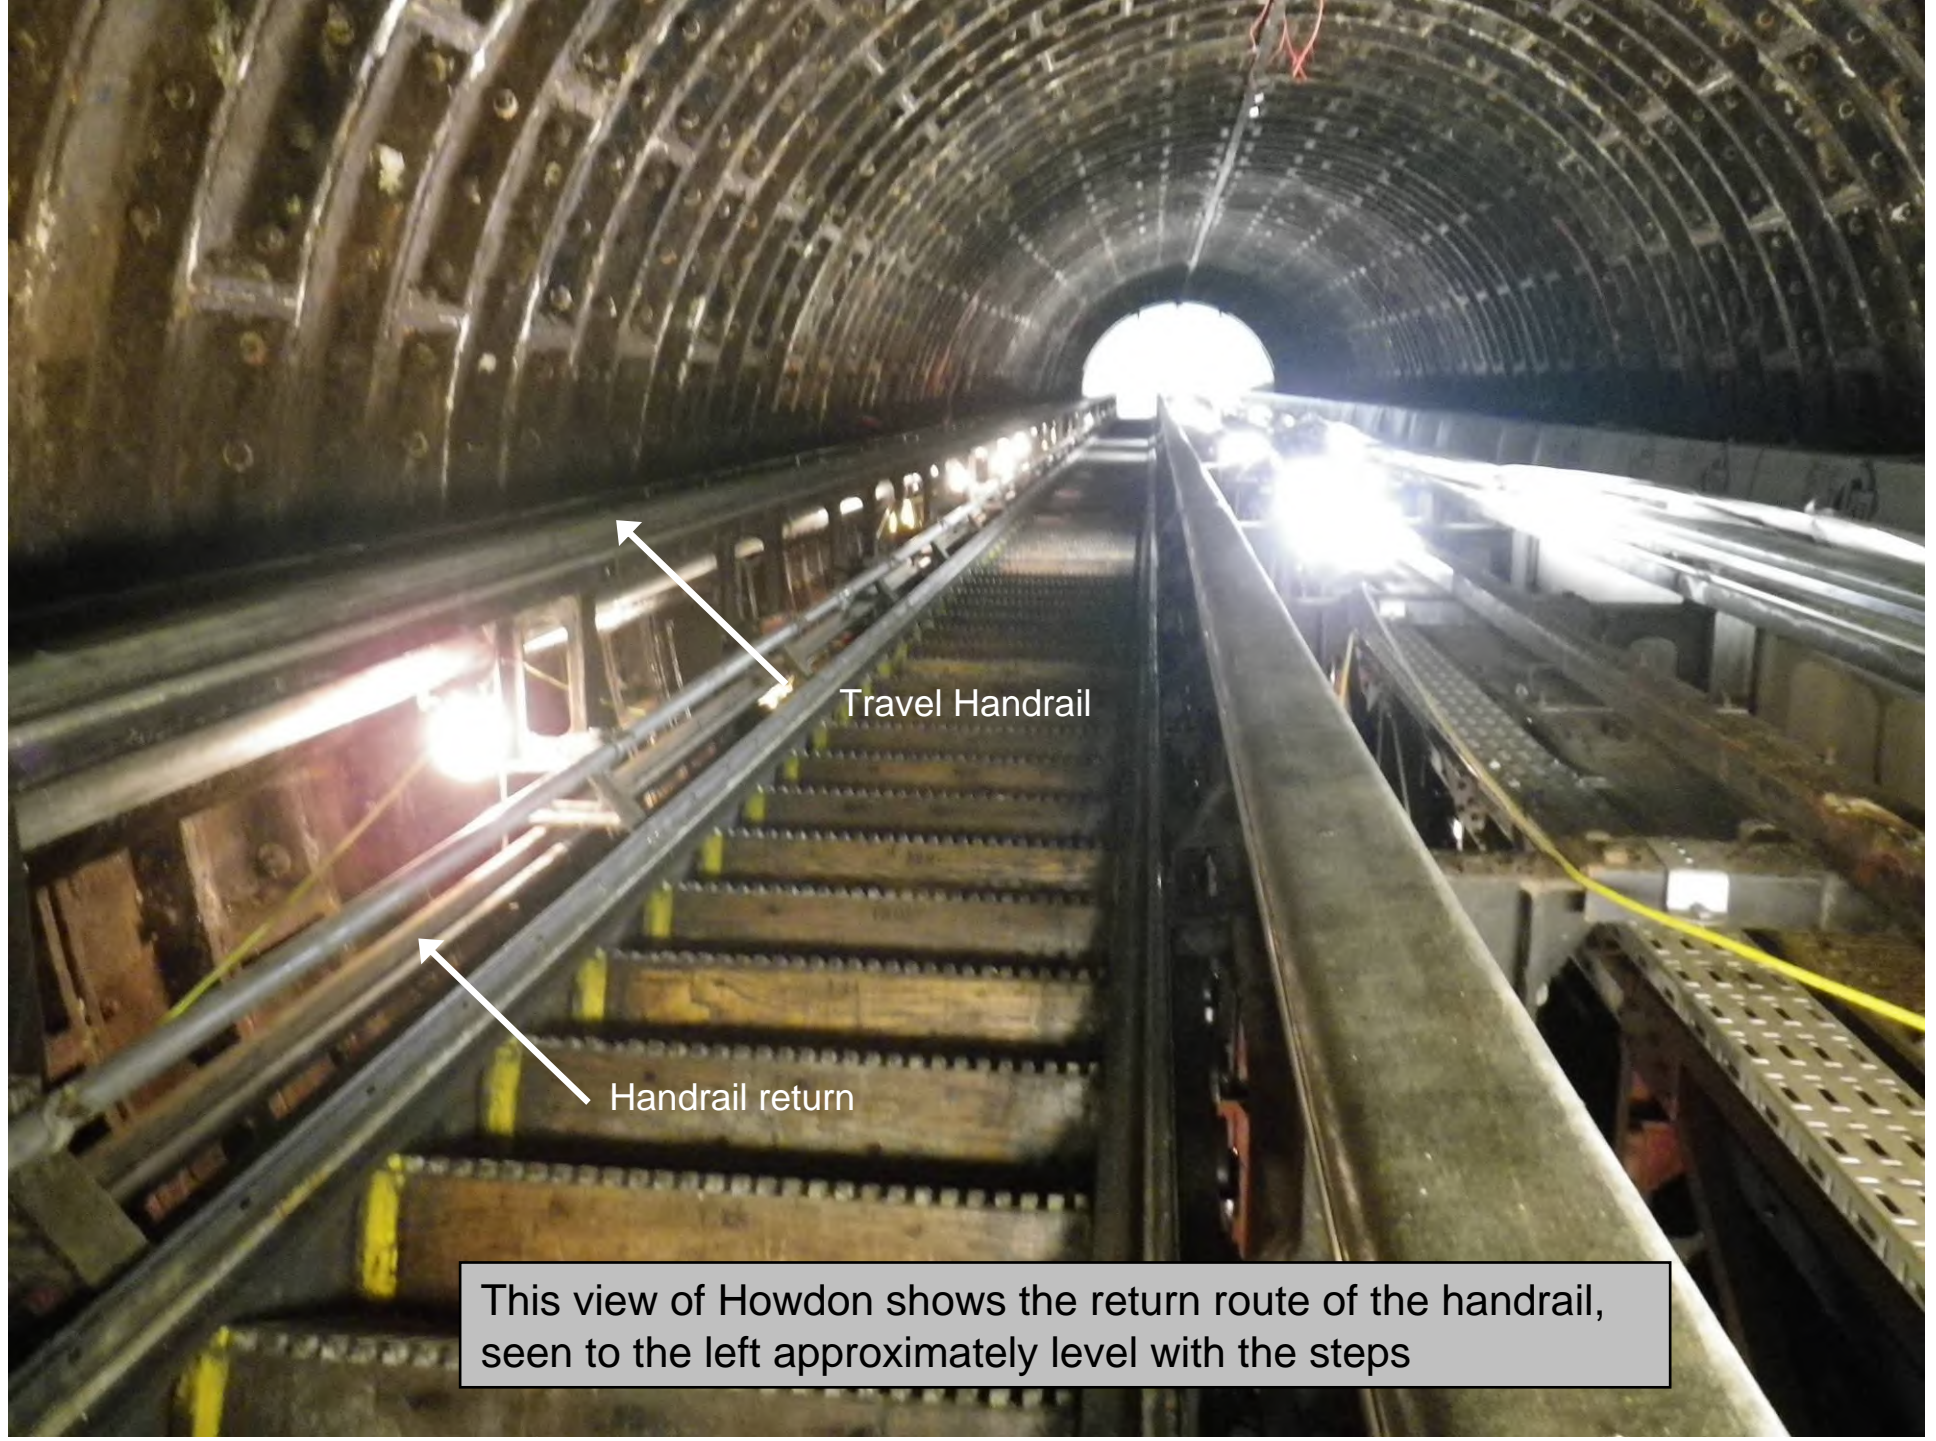
Travel Handrail

Handrail return

This view of Howdon shows the return route of the handrail, seen to the left approximately level with the steps

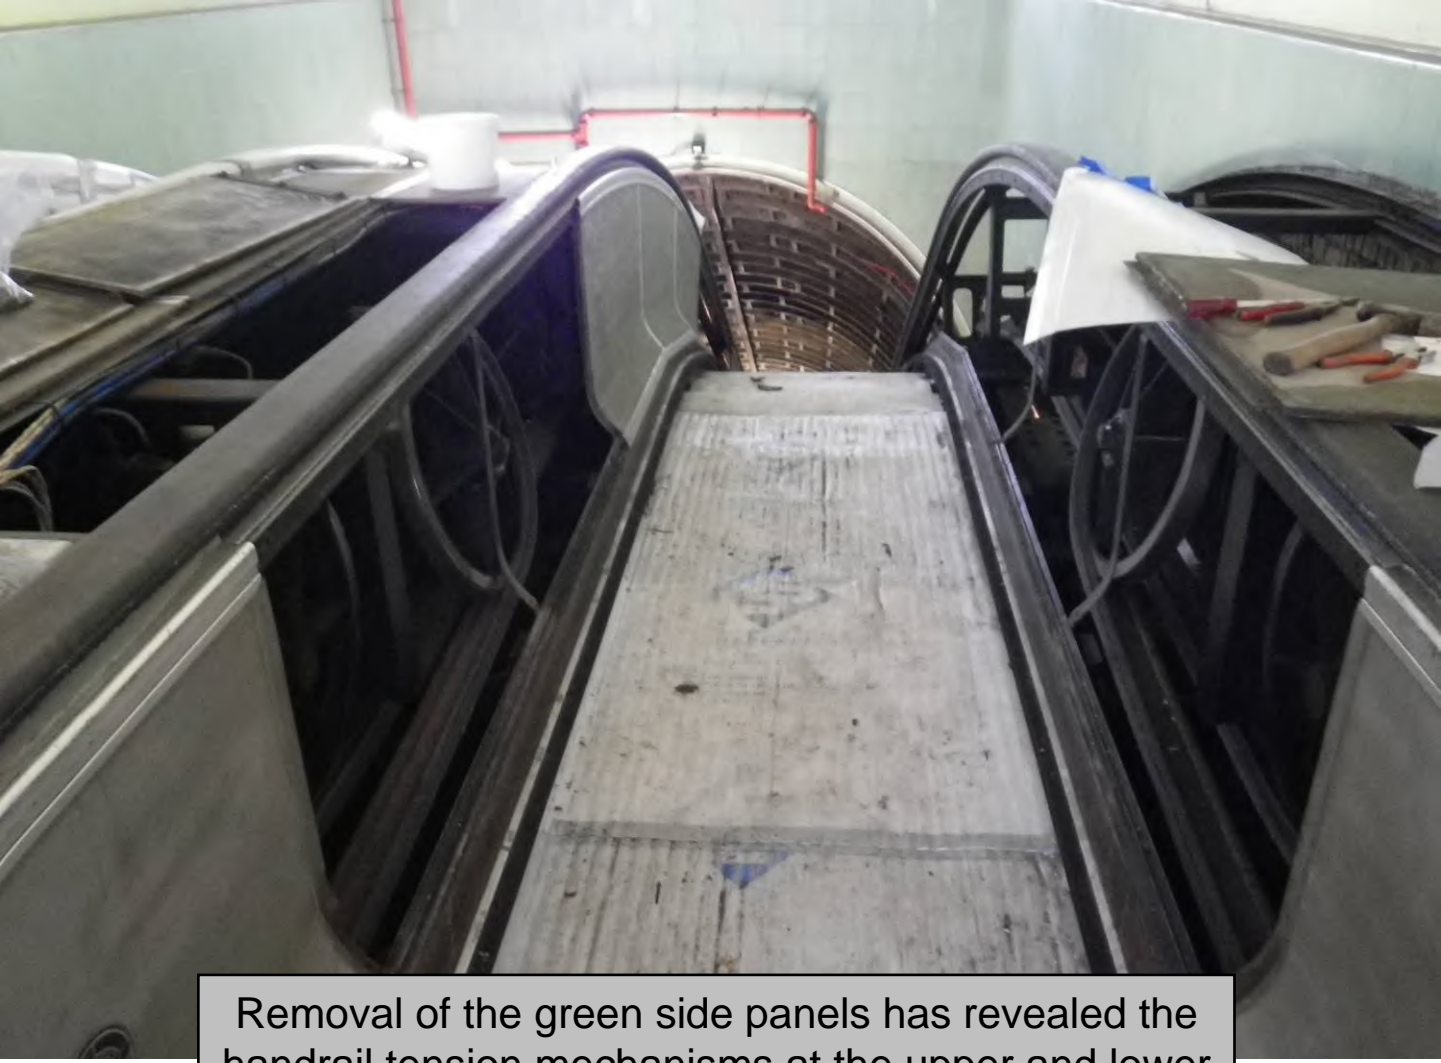
Removal of the green side panels has revealed the handrail tension mechanisms at the upper and lower landings respectively.

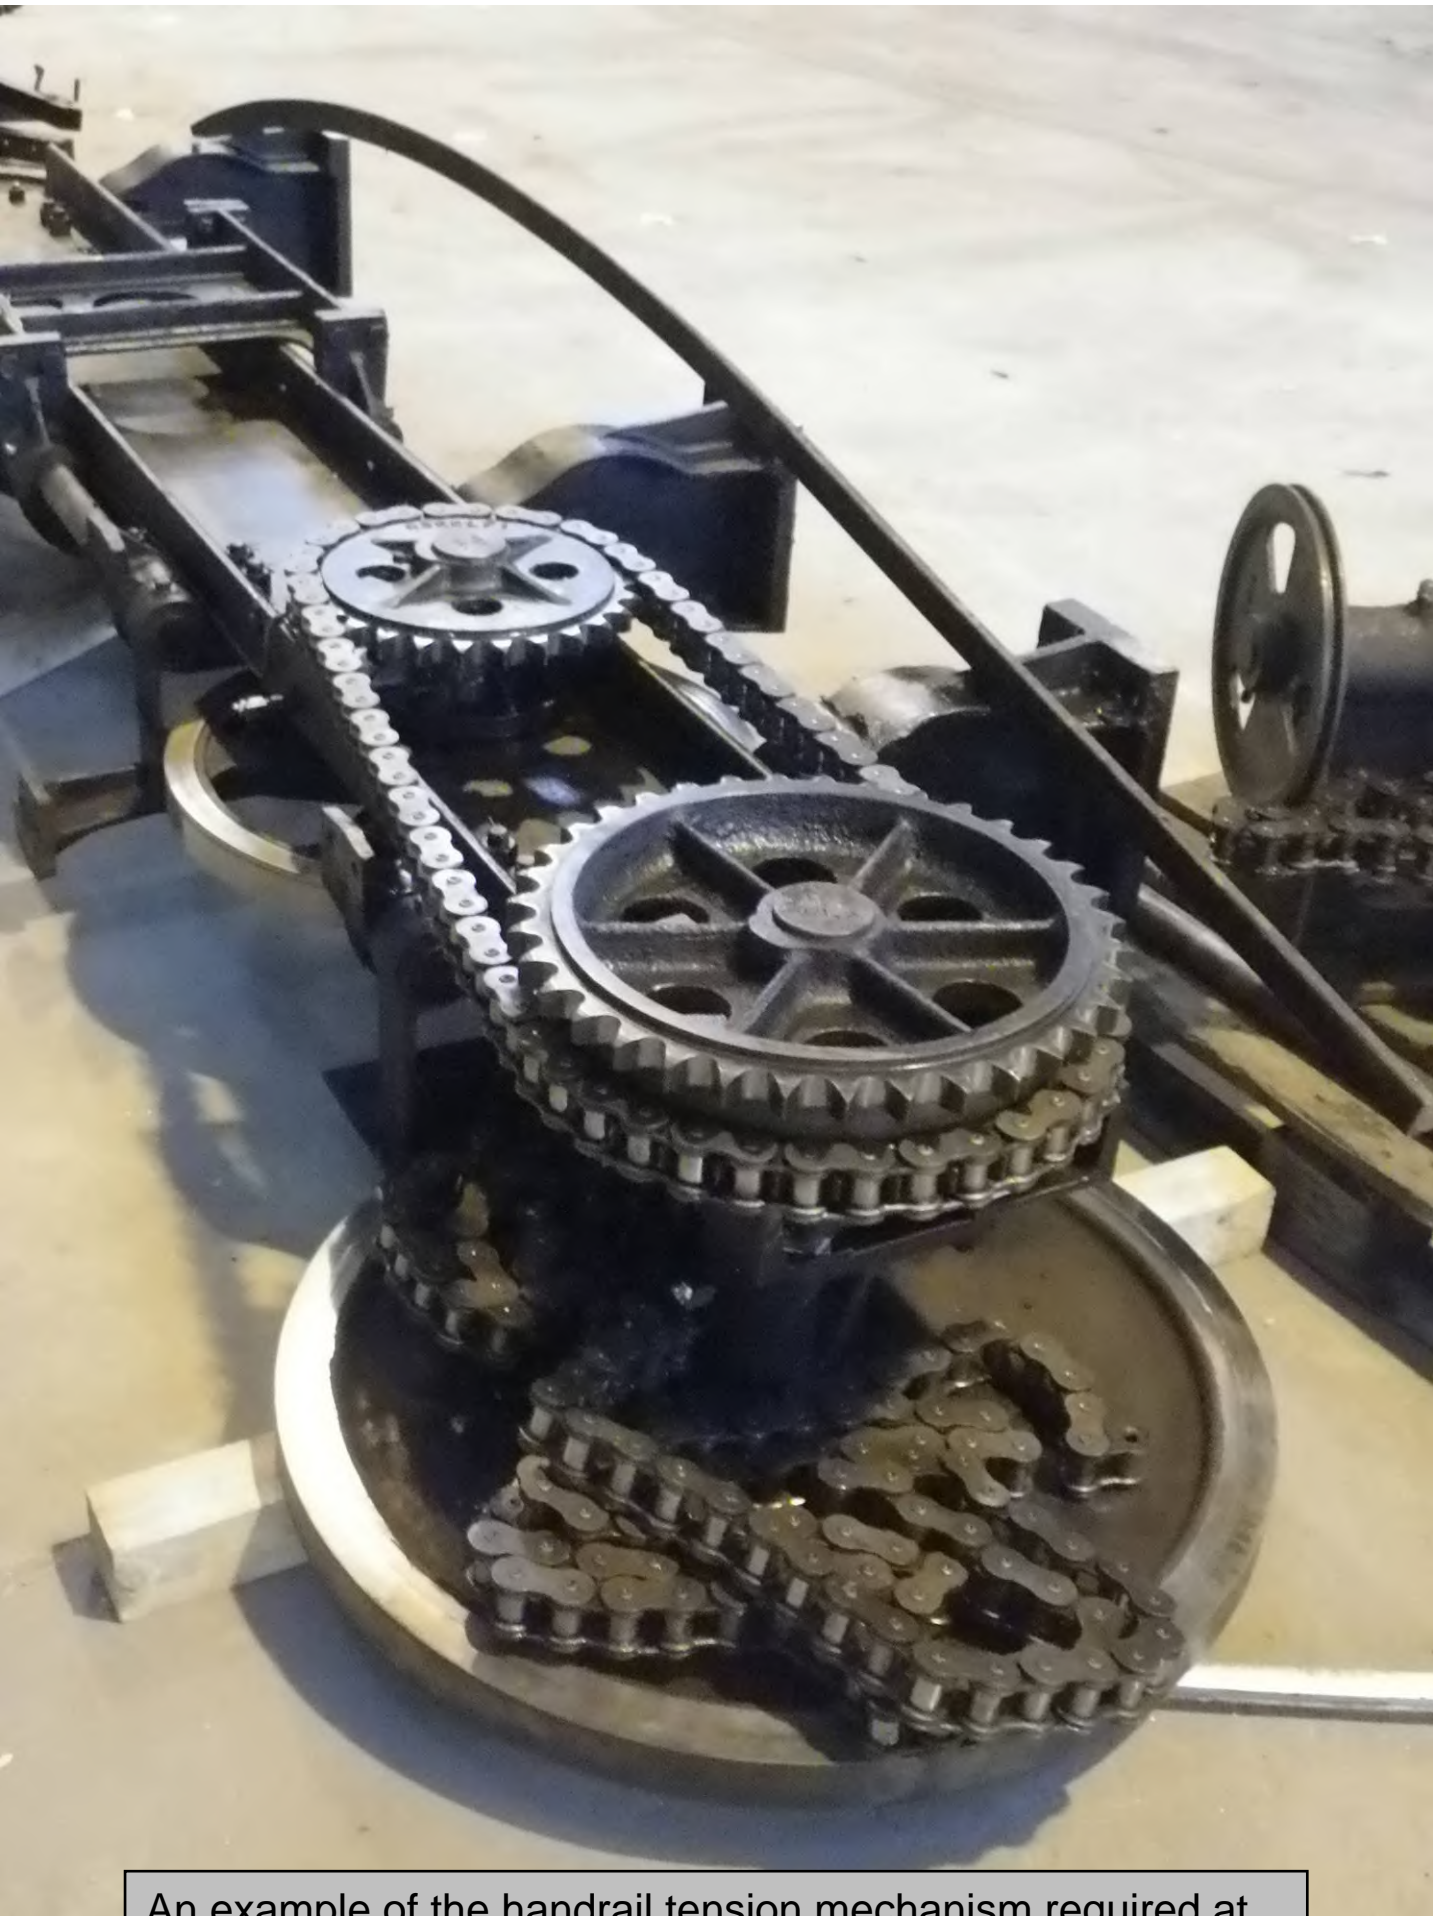
An example of the handrail tension mechanism required at the top and bottom of each handrail, set aside after removal.

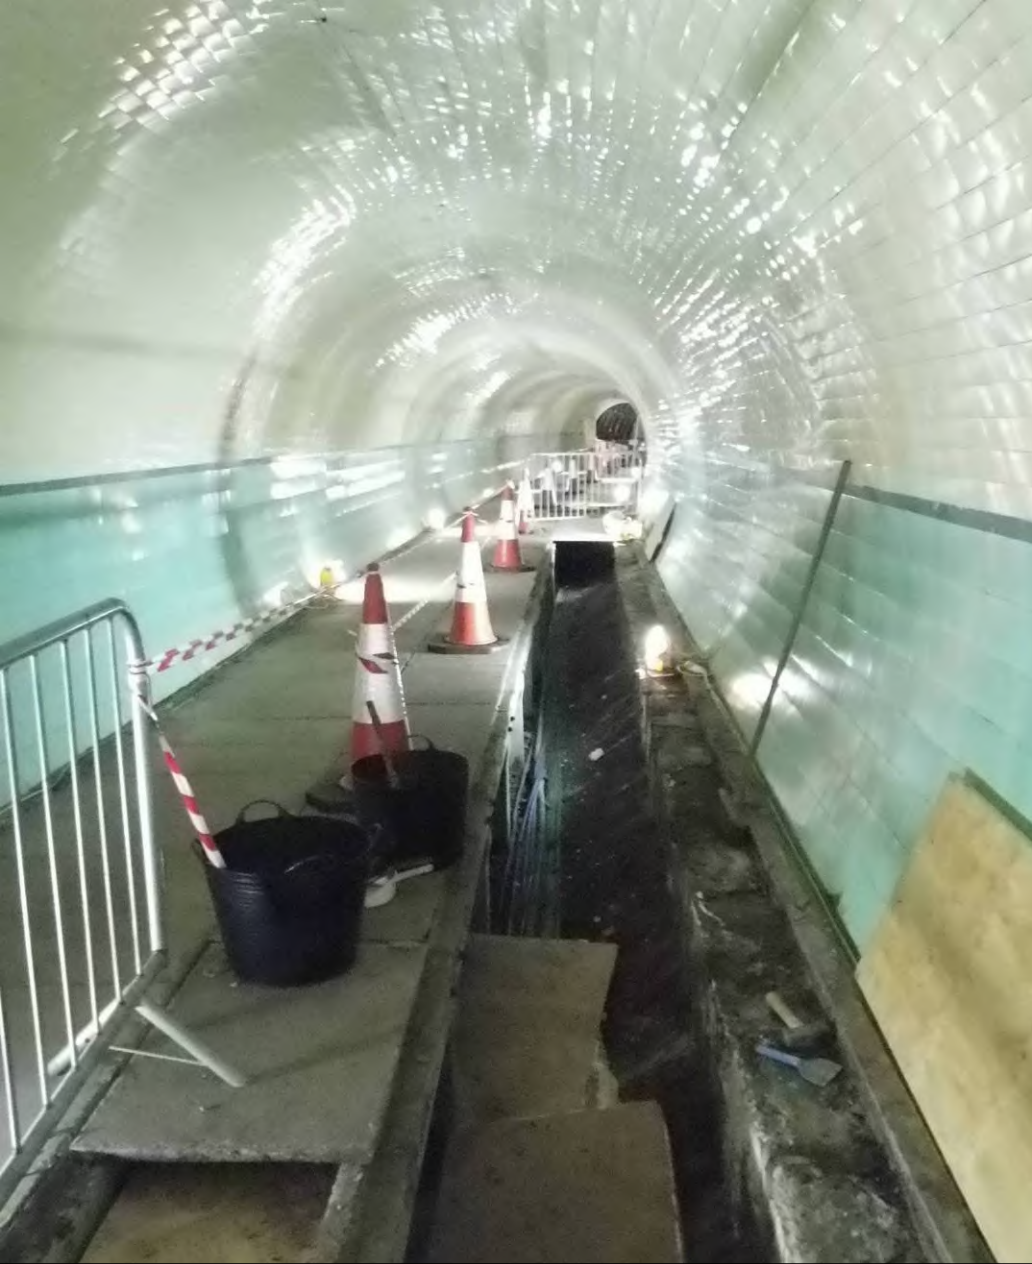
Paving flags in the Cyclist Tunnel have been lifted, to establish the route of much of the mechanical and electrical services for tunnel systems

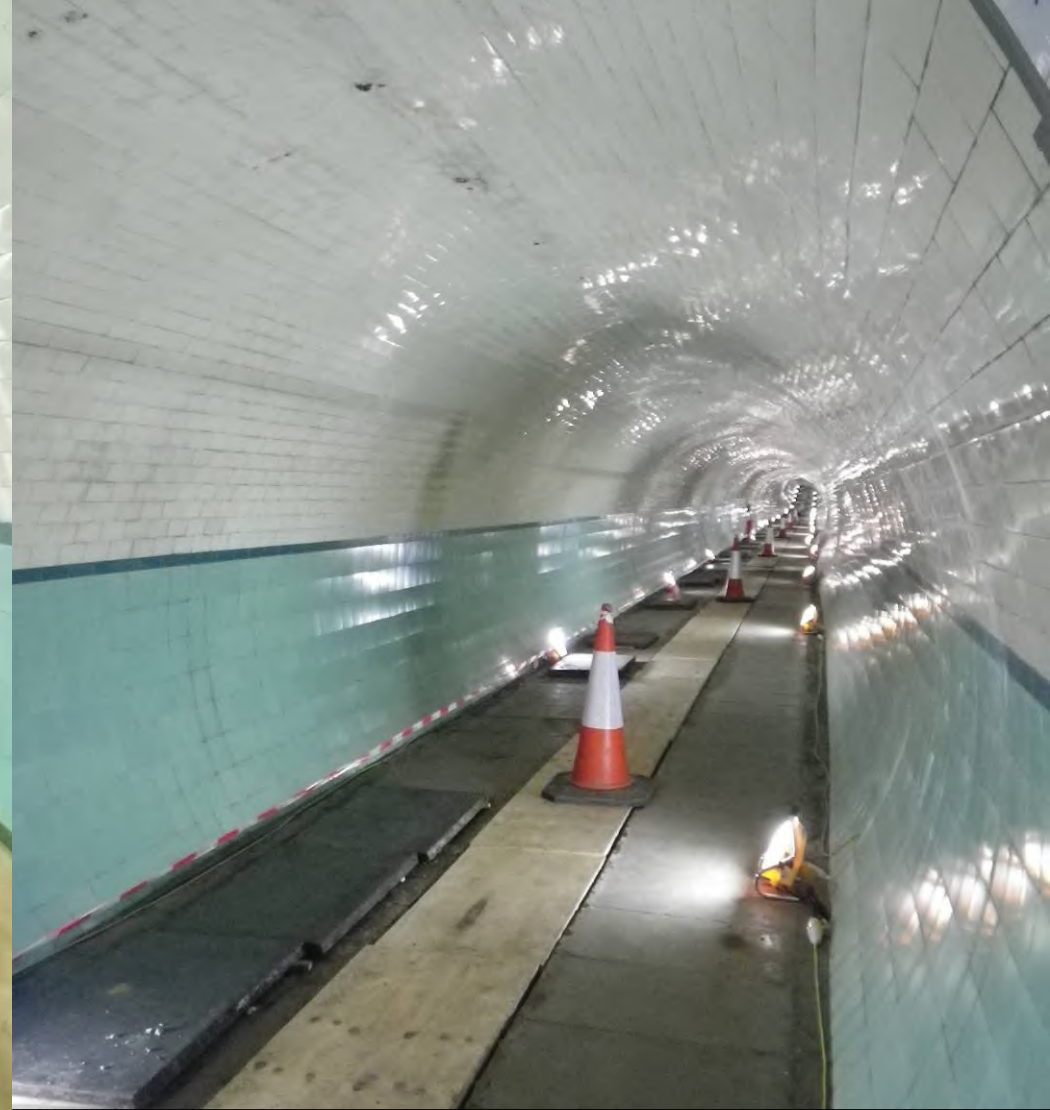
Ceramic tiles have been cleaned in both tunnels prior to repair of damaged tiles and re-grouting.
Sections of flooring in the pedestrian tunnel have been removed for renovation/replacement.
All the existing light fittings have now been removed.
