Tyne Pedestrian & Cyclist Tunnels

**Refurbishment
Progress October 2018**

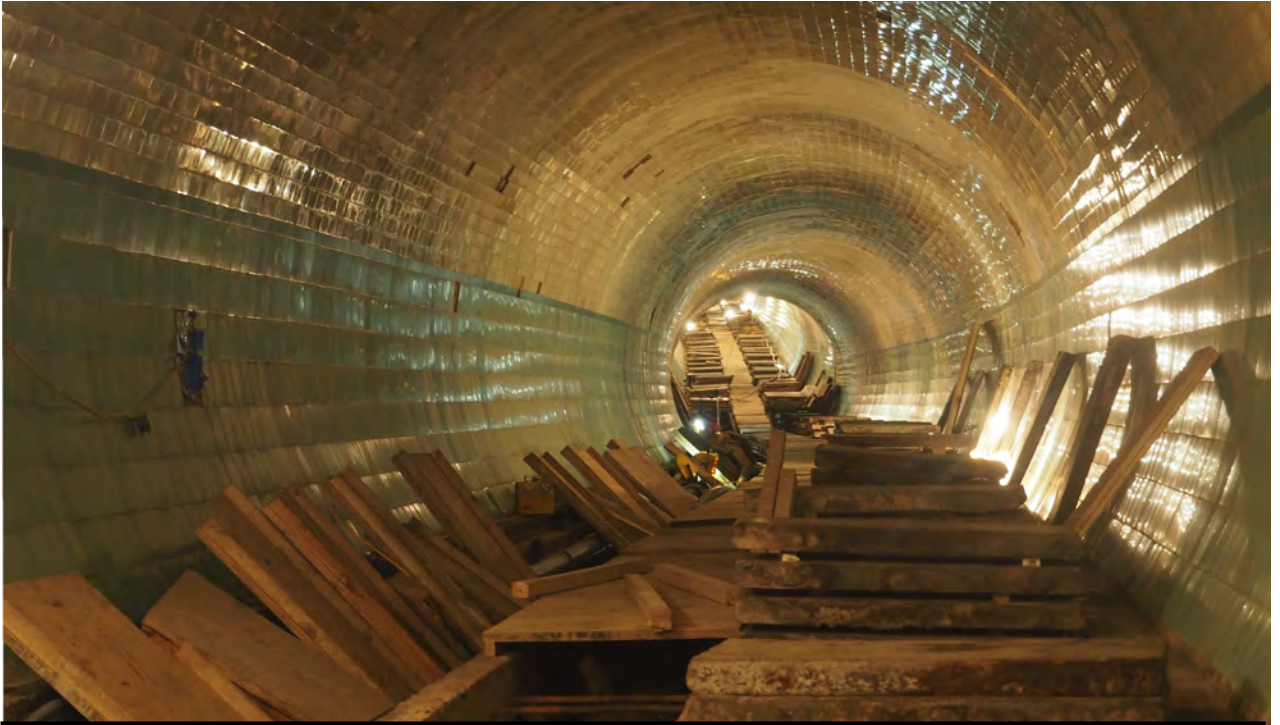
The tunnel paving has been lifted and relayed a number of times during the project to allow installation of new mechanical and electrical systems, to deal with structural repairs and asbestos removal.

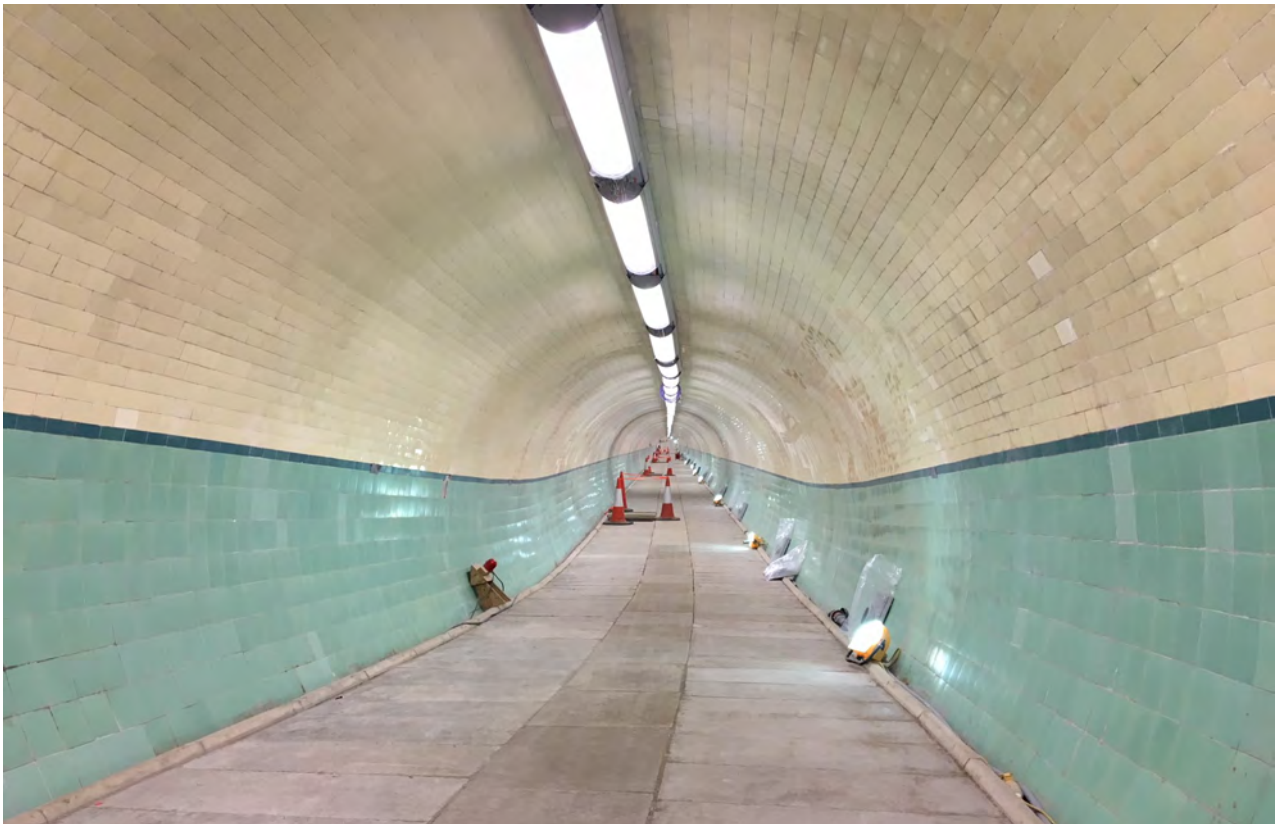
Hundreds on new paving flags have had to be manufactured for incorporation into the tunnels. The new paving flags have now been laid in place. The cyclist tunnel is complete and the contractor is well on with the paving works in the pedestrian tunnel.

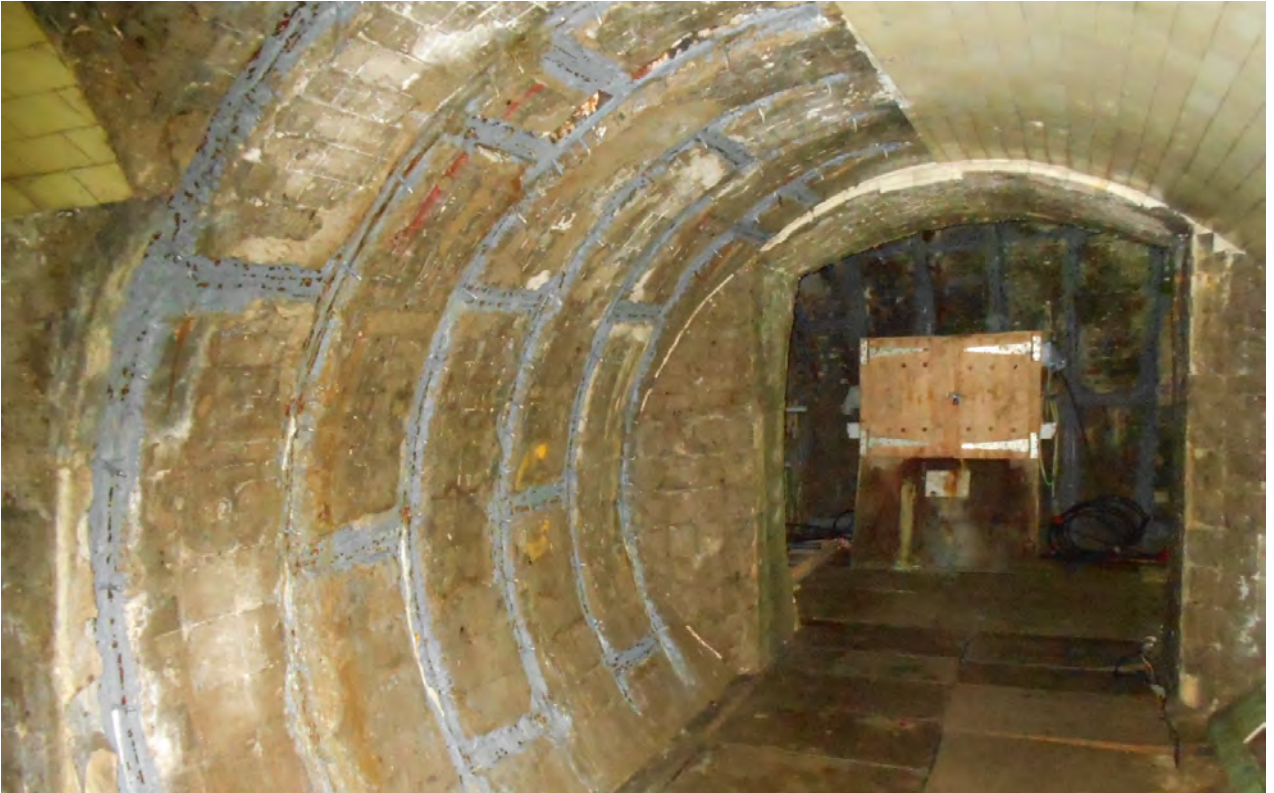
To deal with seepage into the tunnels large areas of tiles had to be removed and 'leaks' injected with resin to seal them.

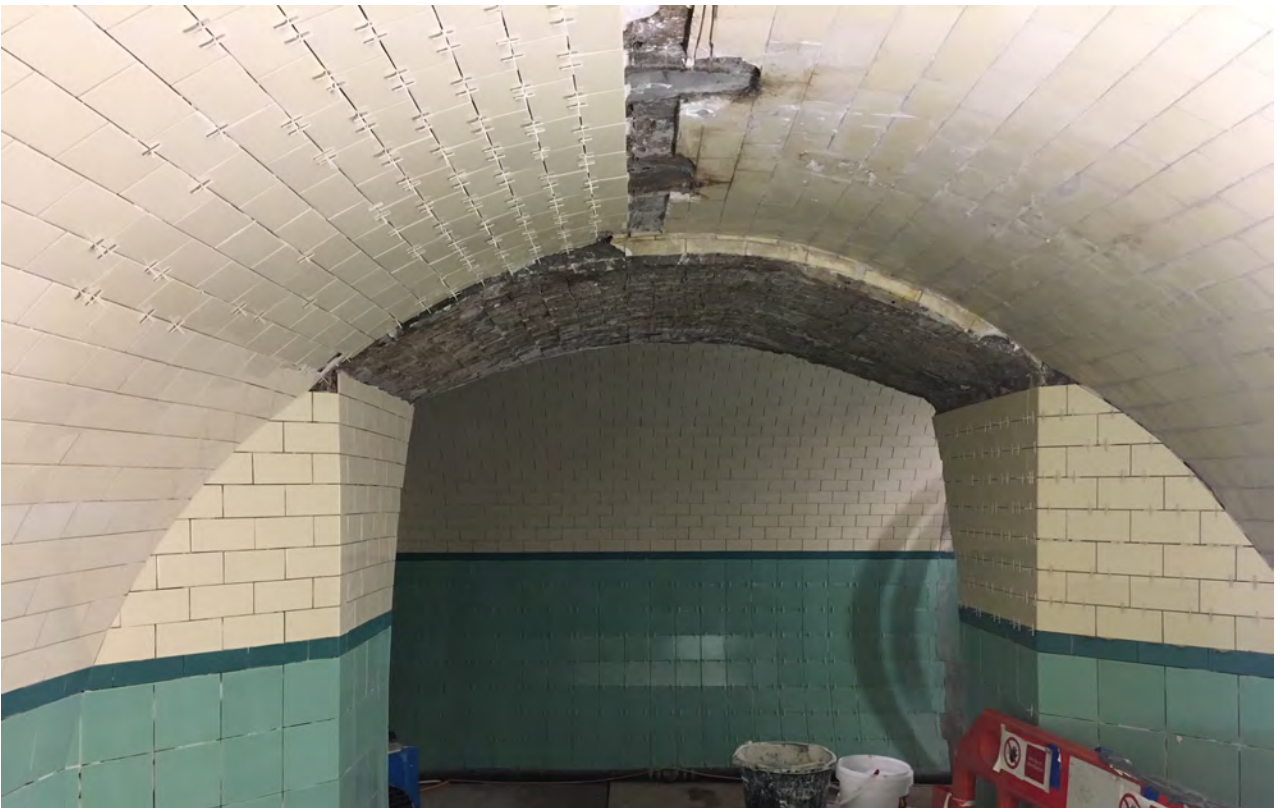
Once the tunnel leaks had been sealed new tiling has been laid. The tiles have been manufactured to match the existing tiles and are installed by heritage trained tilers.

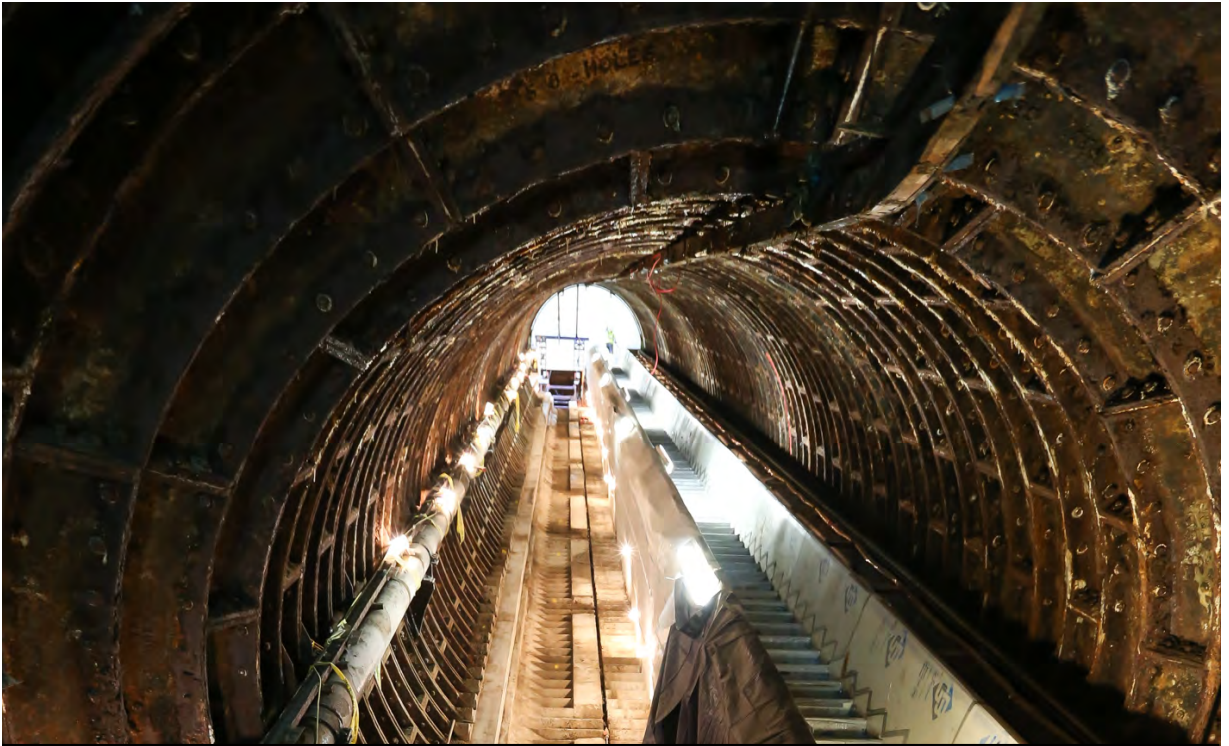
The refurbishment works required the removal of one escalator at each end of the tunnels and complete removal of the cladding system

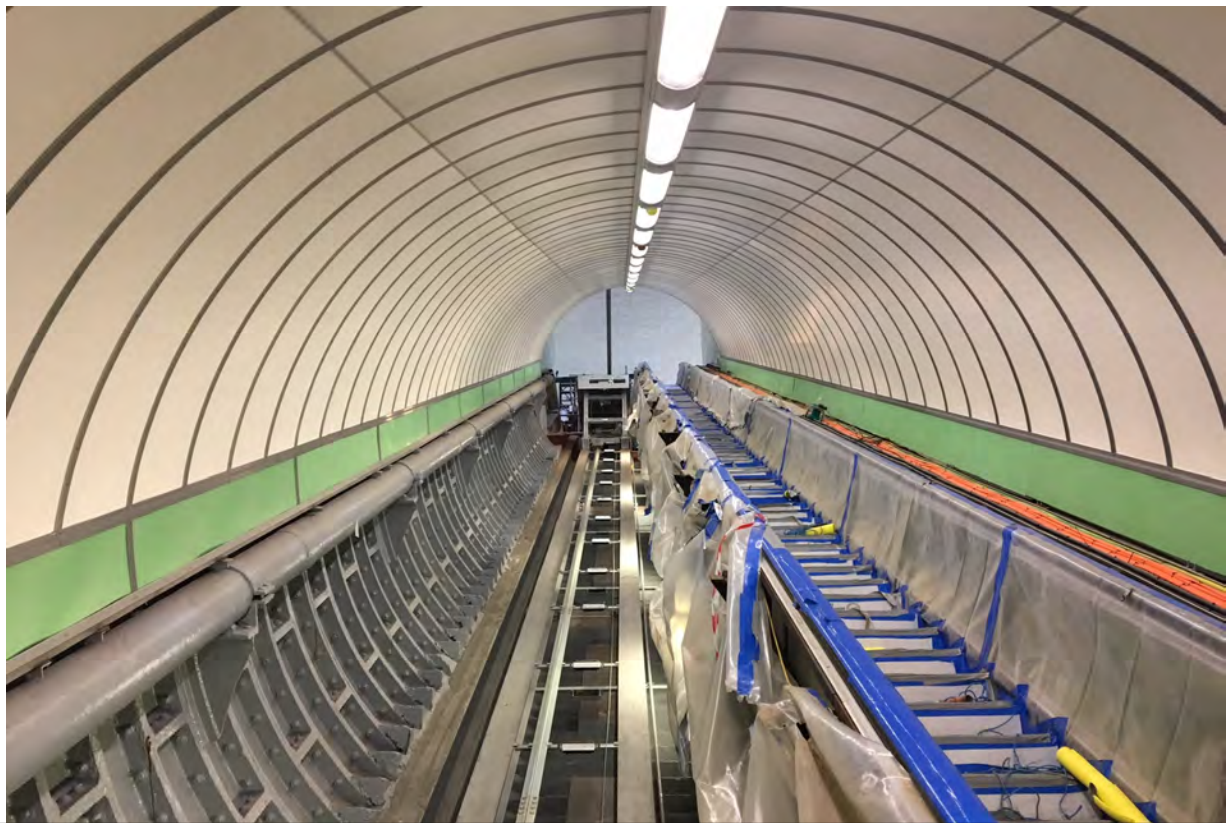
The tunnel lining has now been sealed, electrical and mechanical systems installed and the cladding panels renewed. The new inclined elevator installation is ongoing.

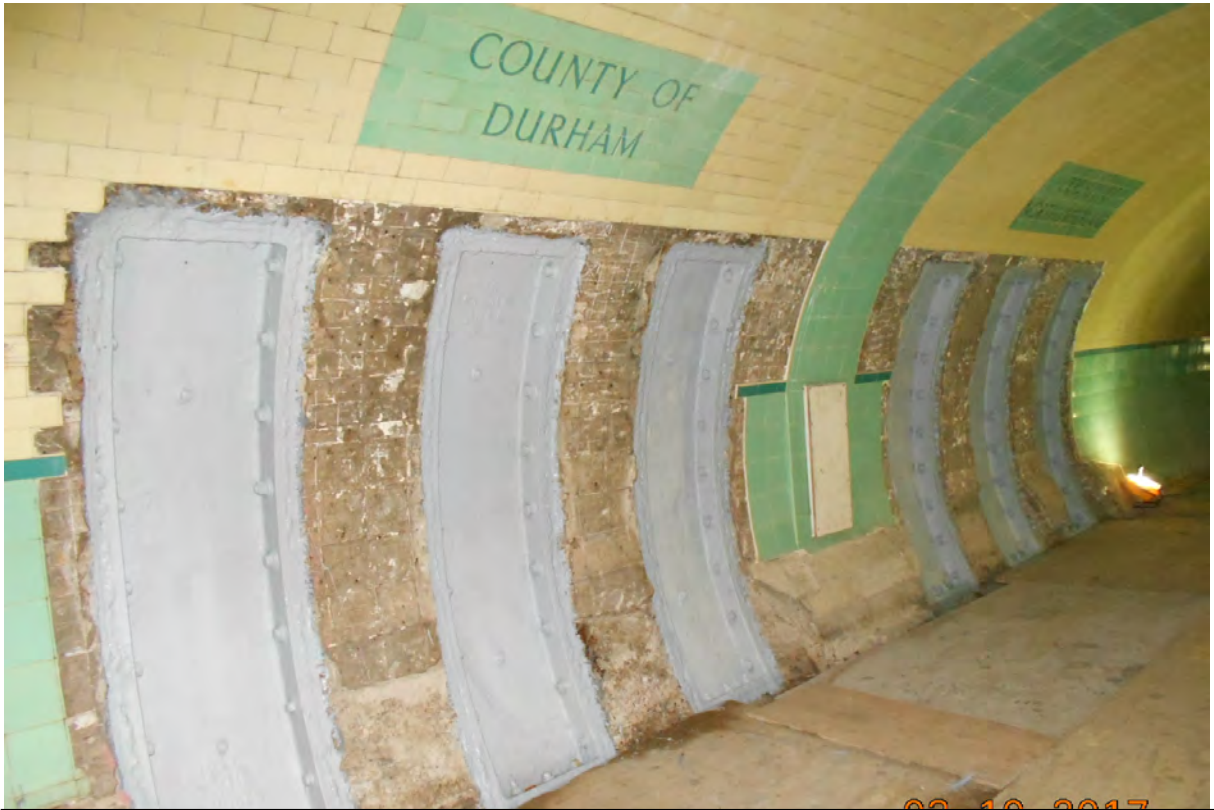
The ventilation ducts in the centre of the tunnel had to be completely replaced.

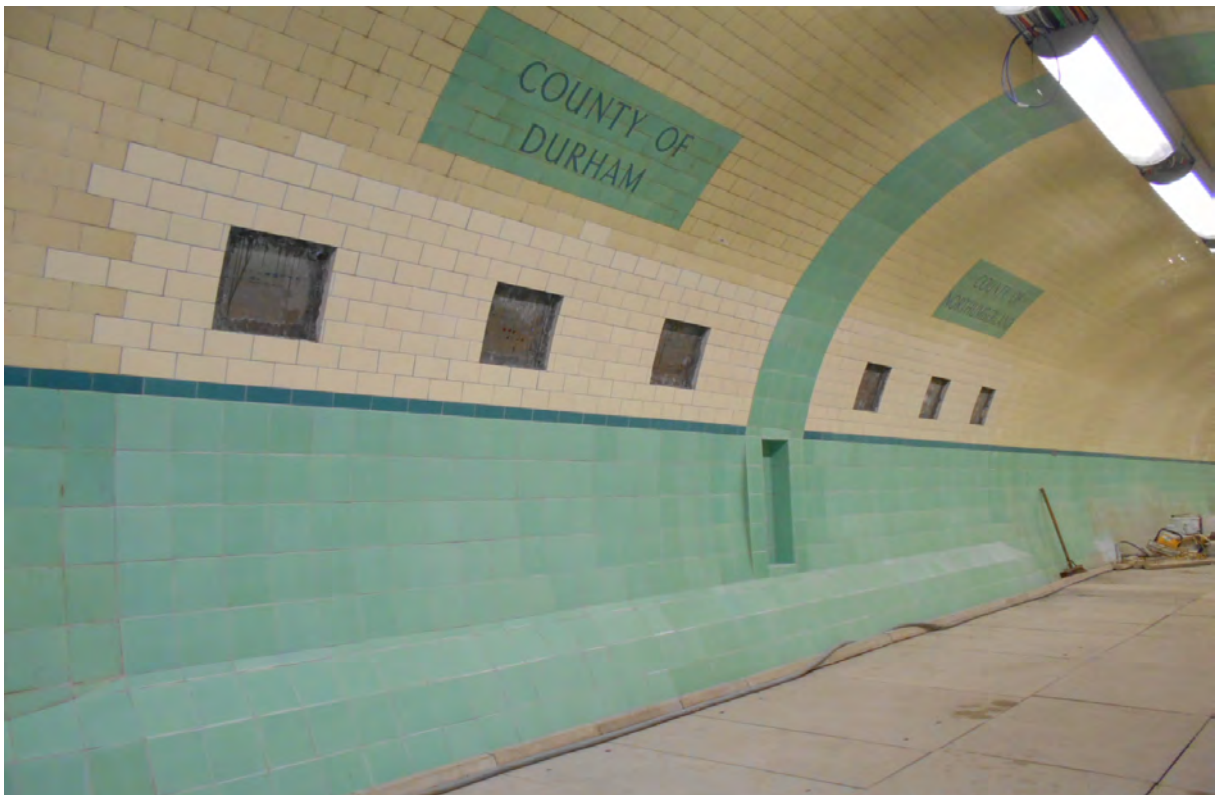
Following the installation of the new ventilation ducts the tiling has been replaced and only the duct covers remain to be installed.

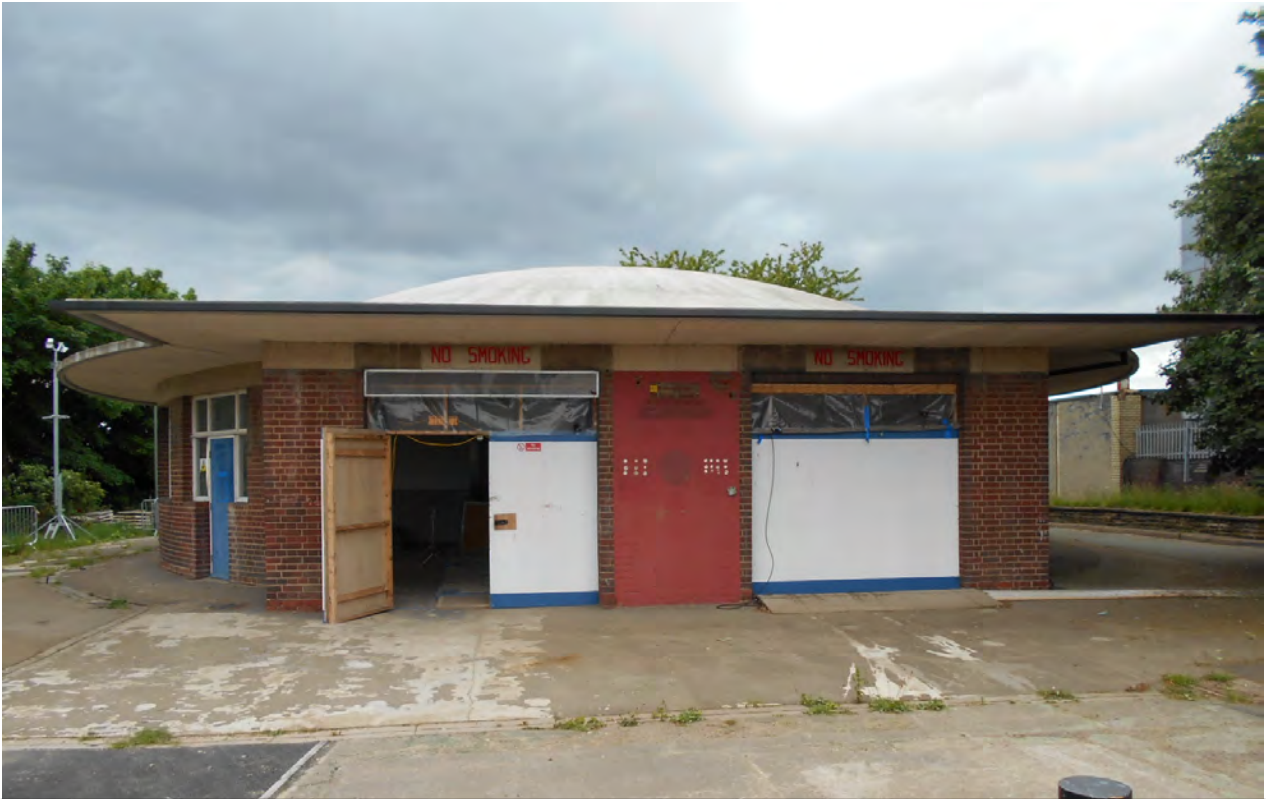
The external fabric of the rotunda buildings is being repaired and cleaned up. The concrete slab in front of the building has had to be fully replaced.

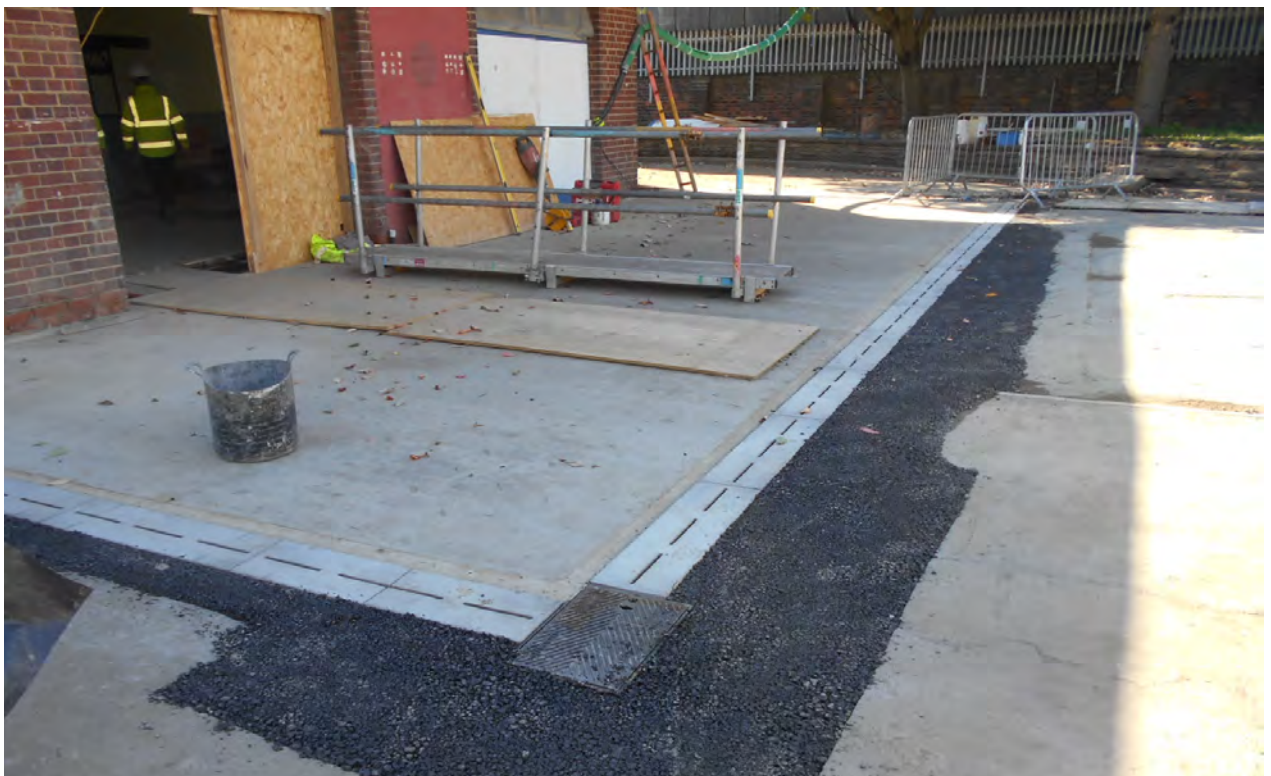
The concrete slab in front of the rotunda building has now been replaced as has the drainage. The next element of works externally is the replacement of the surfacing.

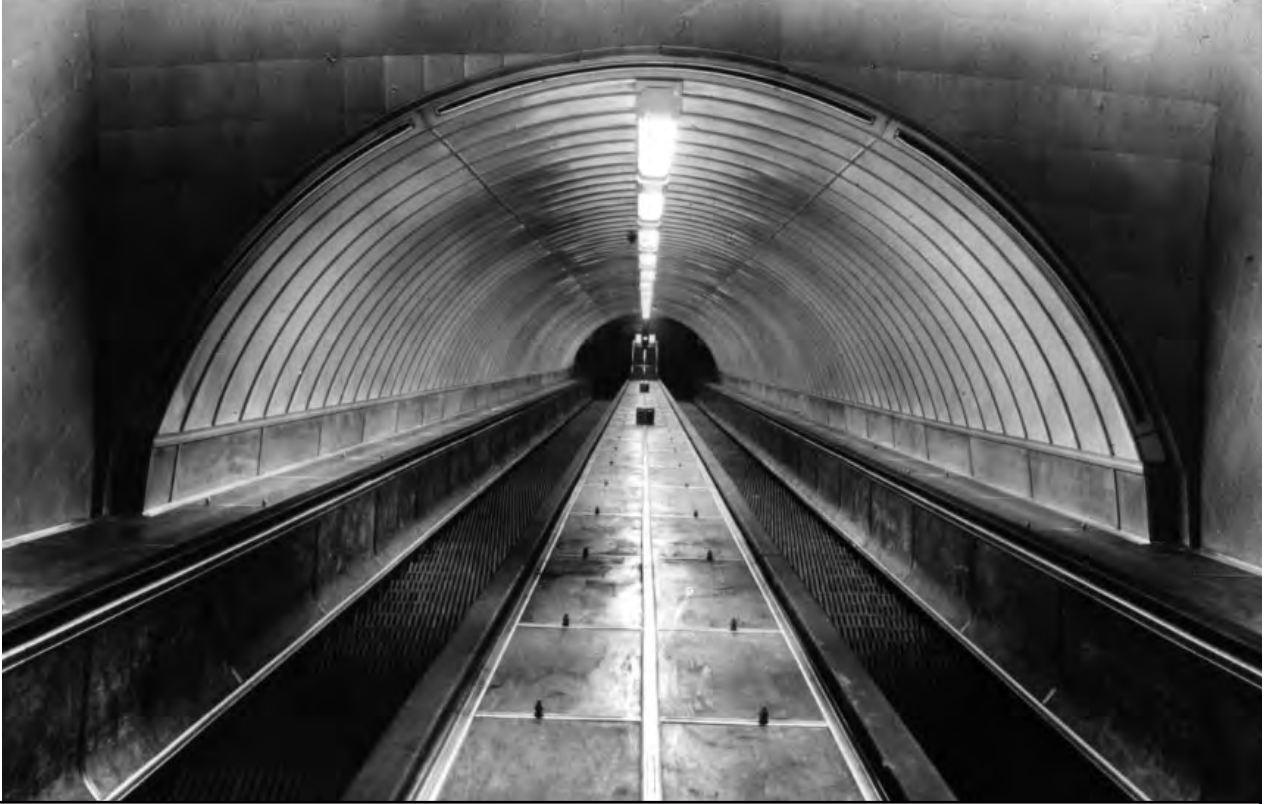
The refurbishment has seen one of the original escalators removed to make walk for the new inclined lift. But we have looked to retain the original character of the structure.

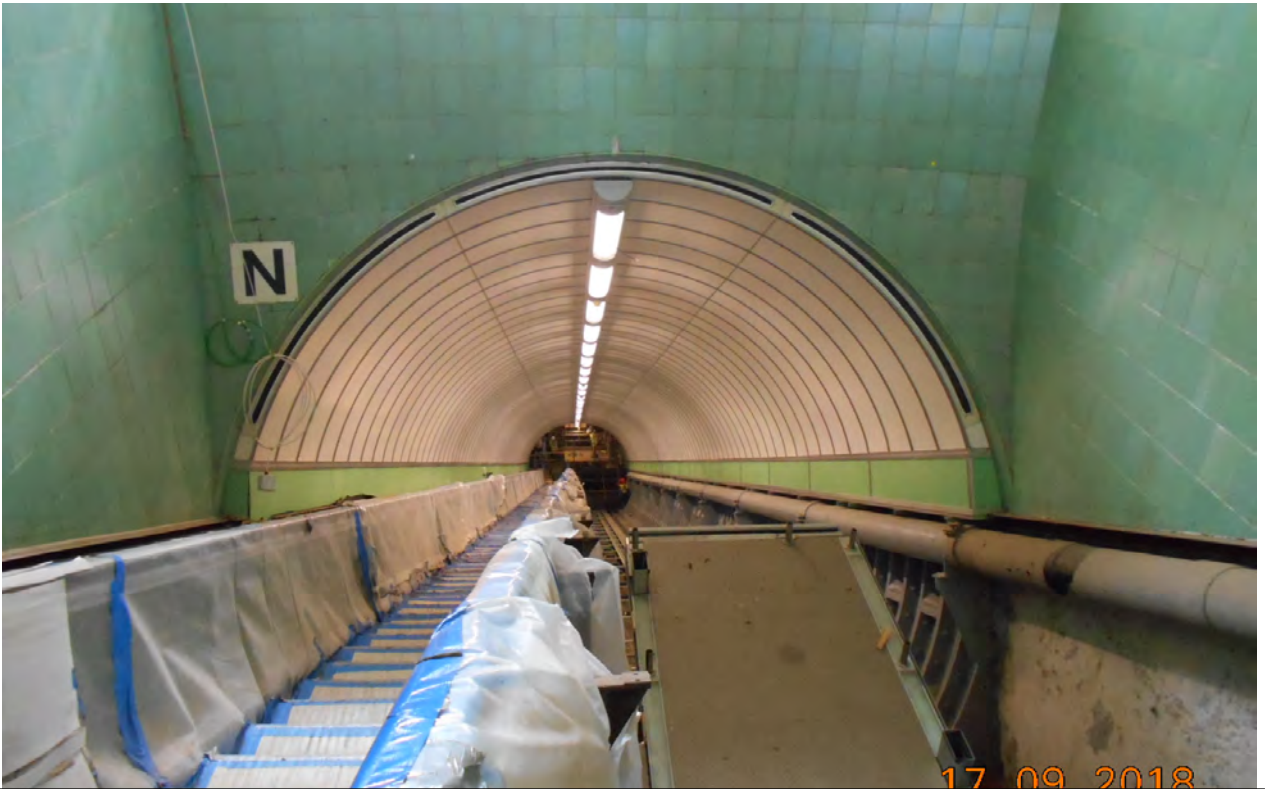
The scaffolding in the incline has now been removed to allow the inclined lift car to be completed. This will involve installing the glass walls and roof.
